EXPERIMENTAL INVESTIGATION INTO THE DETERIORATION OF CONCRETE SUBJECTED TO HYDRO-ABRASION

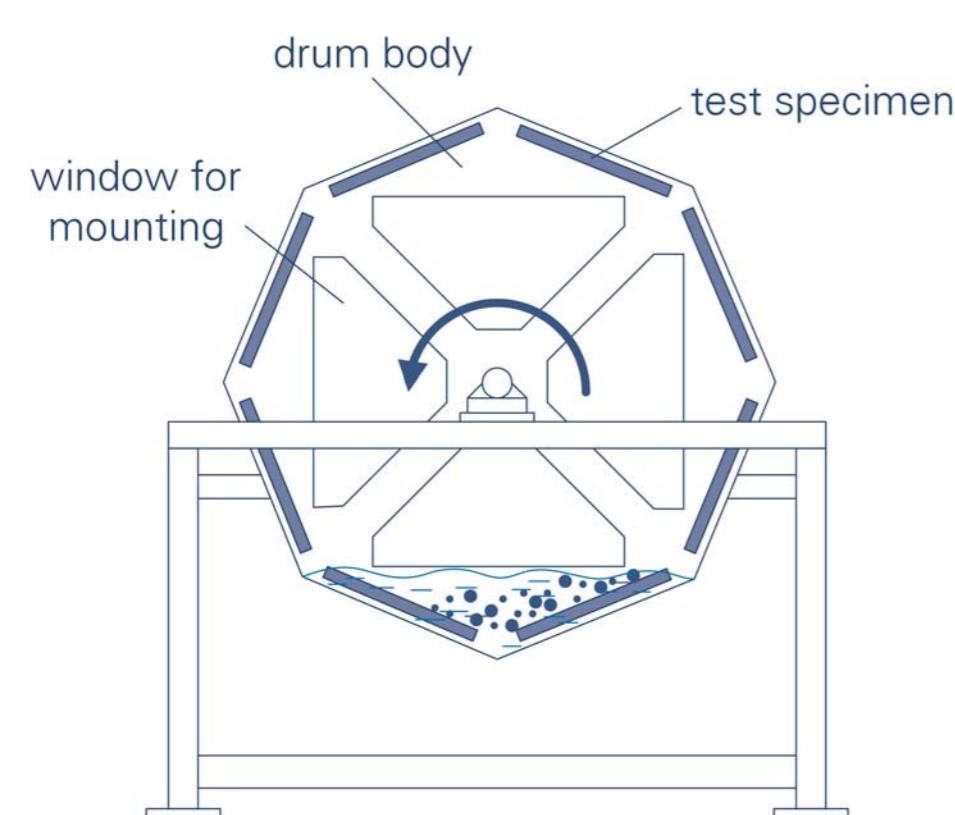
Sketch of abrasion test facility

- slab size: 300 x 300 x 50 mm³
- abrasion regimes: upper reaches (R1), middle reaches (R2), lower reaches (R3)
- rotation velocity: 10 – 17 rot/min

- abrasive material: 10 kg steel balls

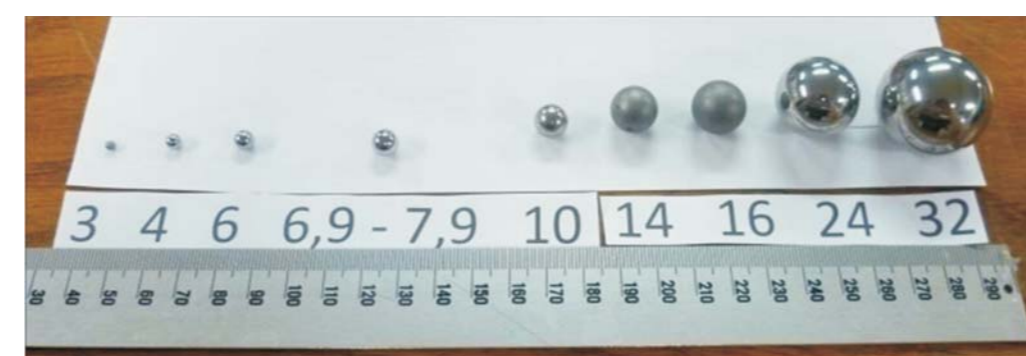
Size of abrasive material in abrasion regime R1

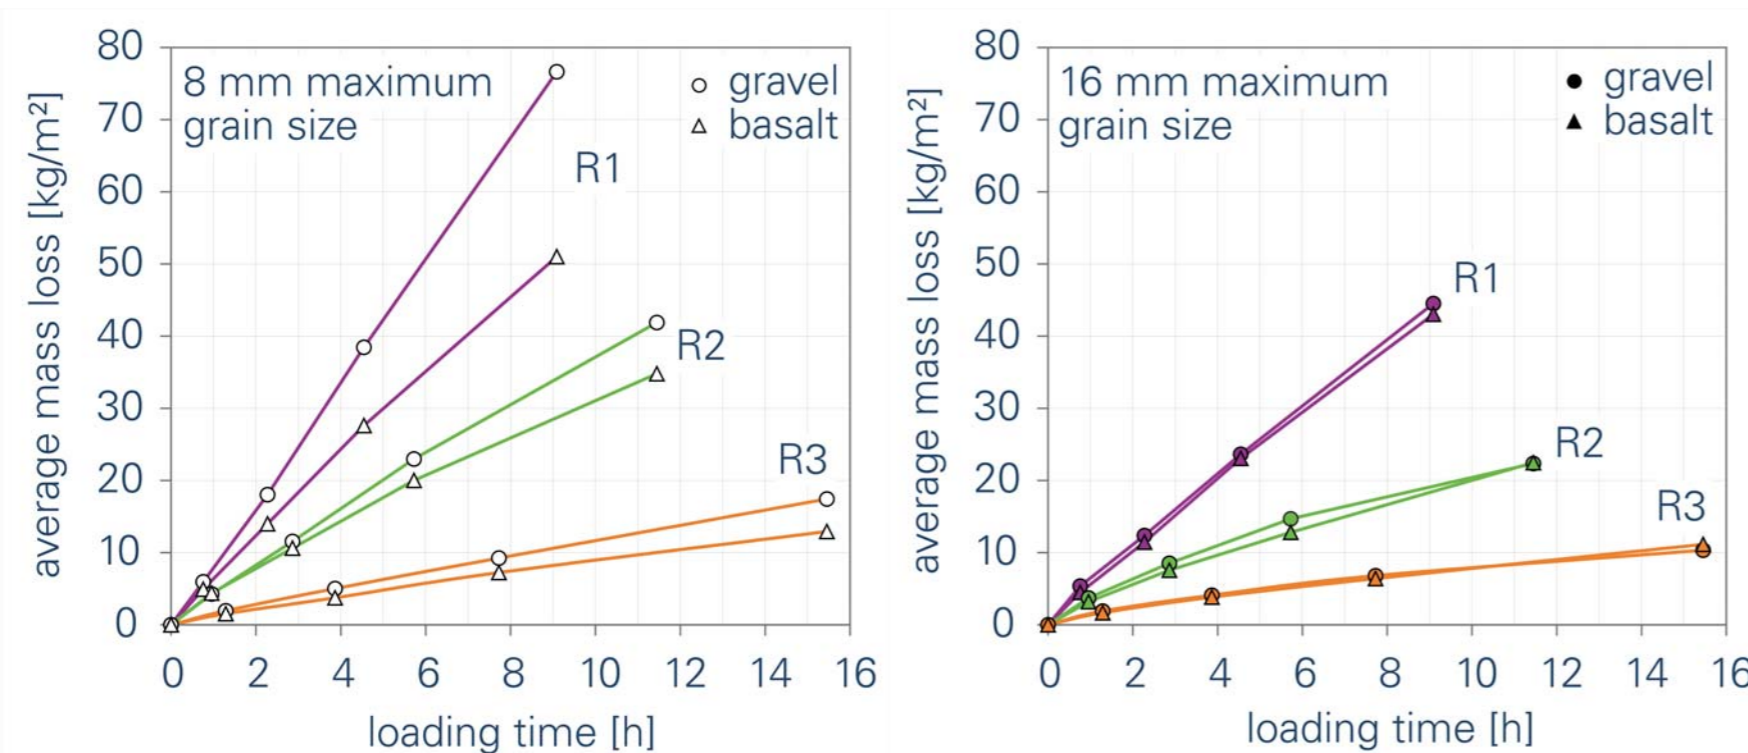
- wear resistance strongly affected by type and maximum size of the aggregates and energy input

Typical results of average mass loss; 8 mm (left) and 16 mm (right) maximum size of the aggregates

- abrasion resistance affected by type and size of aggregates
- characterisation of structural deterioration by means of ultrasonic measurements
- microscopical visualization of damage caused by hydro-abrasion
- crack formation and spalling of concrete fragments

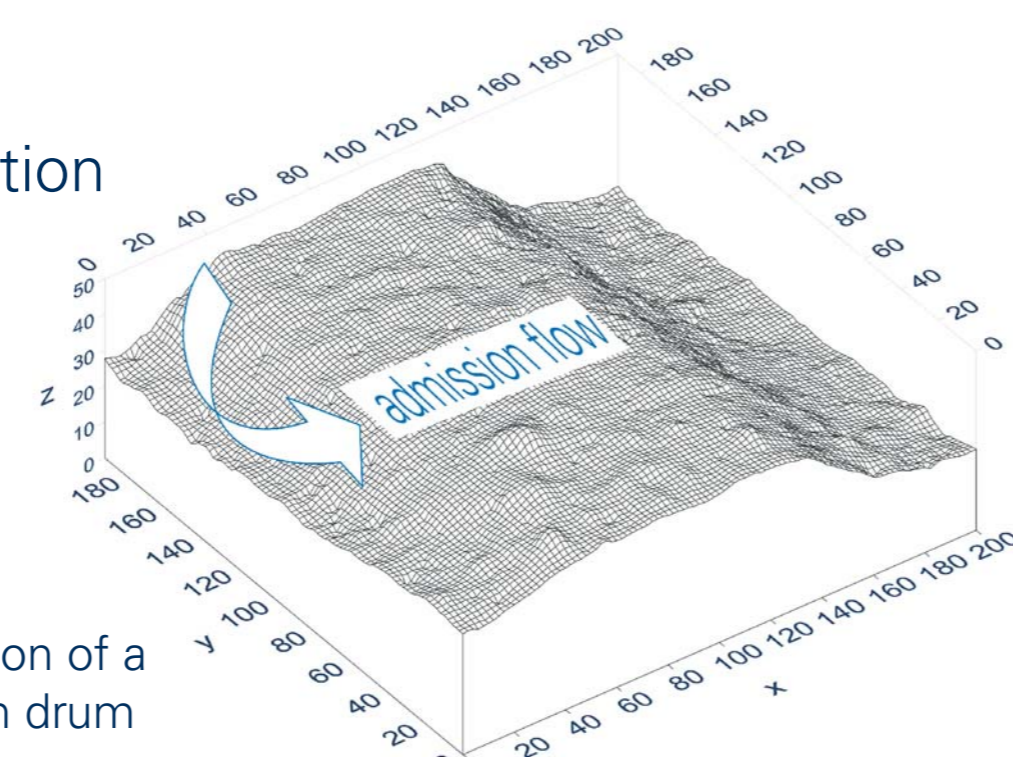
- supplementary information on surface condition
- detection of system-inherent phenomena

Surface condition with rib formation of a concrete slab after hydro-abrasion drum test in upper reaches regime

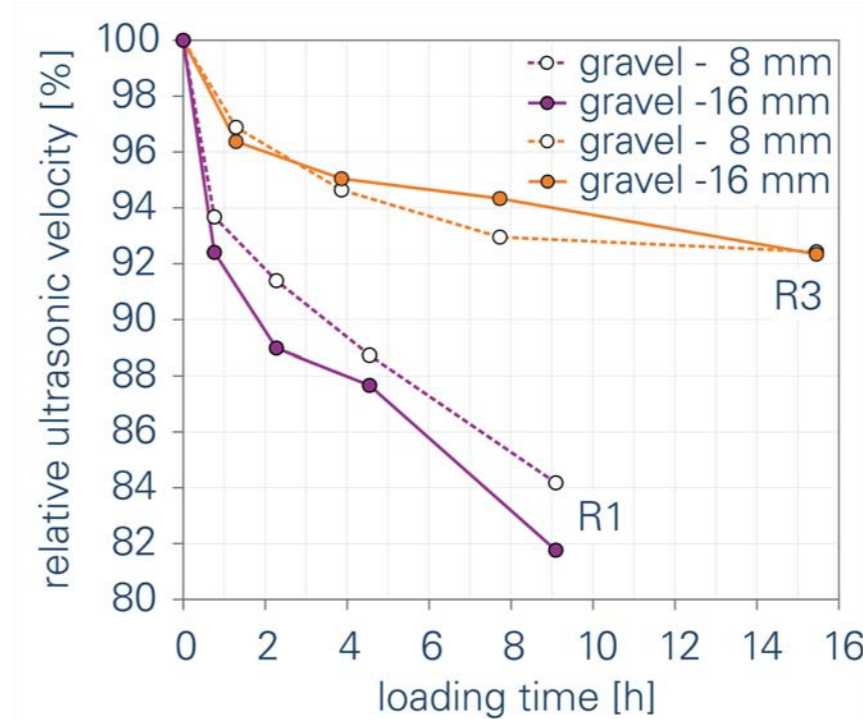
- underwater surface measurement

Typical results of ultrasonic testing on damaged slab surface

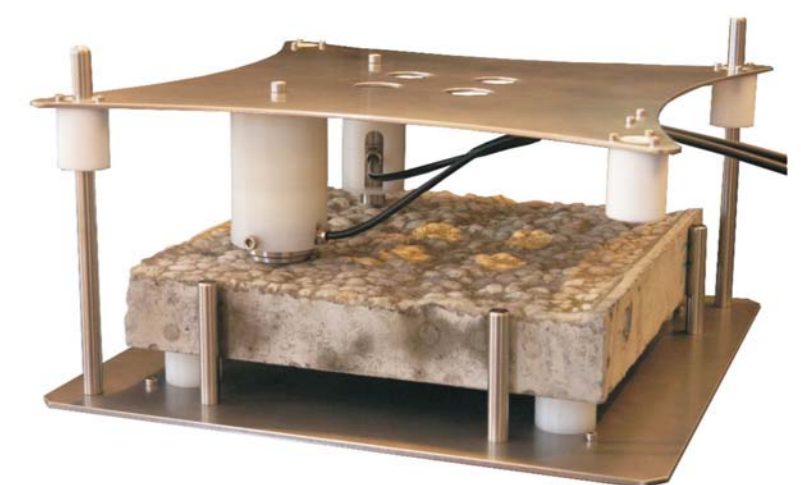
Experimental setup for ultrasonic testing

- transit time determination of longitudinal wave
- encoder frequency: 80 kHz
- sampling rate: 10 Mhz

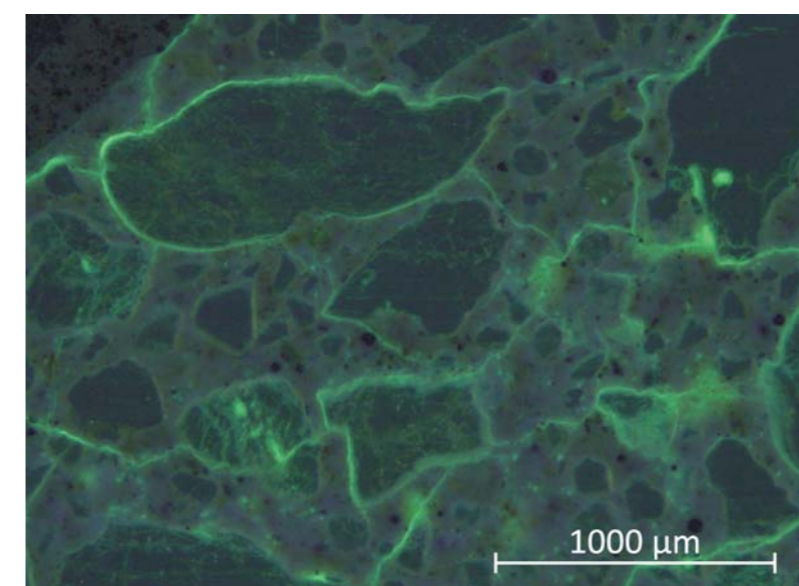
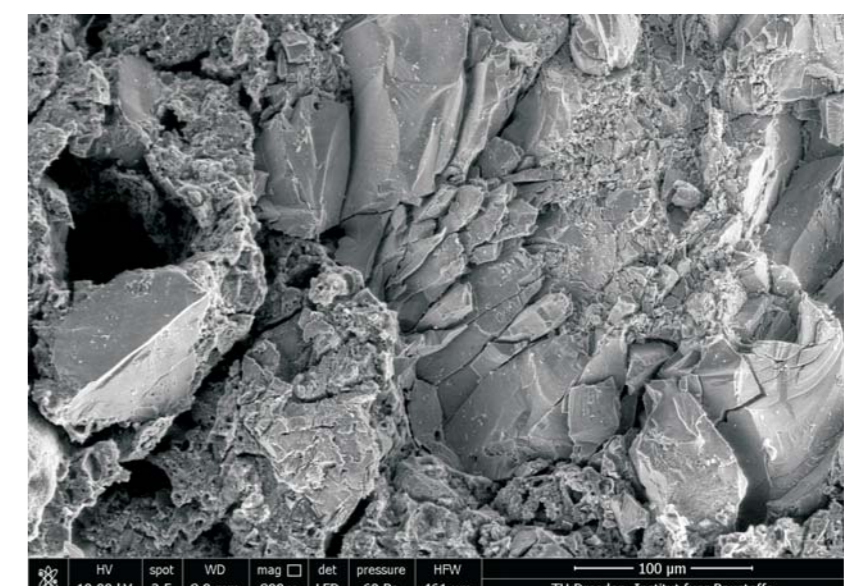
- light microscopy of fluorescent thin section samples
- Environmental Scanning Electron Microscopy (ESEM) of damaged surface
- typical damage of concrete subjected to hydro-abrasion:

Left: crack pattern of concrete meso-structure 15 mm beneath the slab surface
Right: smashed aggregates on the damaged slab surface
